Lightning strike

The AAIB's findings into last spring's devastating lightning strike on a London GC K-21, when two people parachuted to safety, are now public. S&G reports on what can be learned

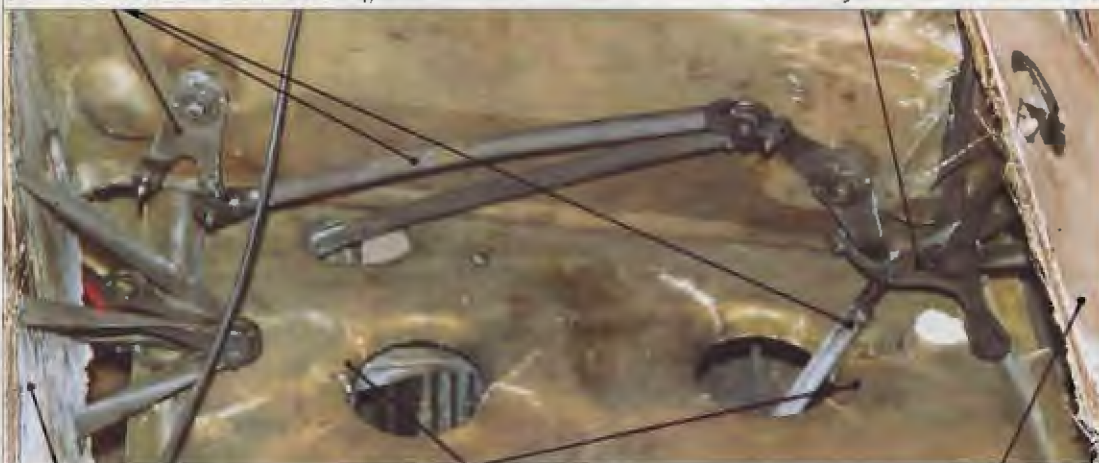
The result was devastating (see *The final minutes of GBP*, bottom right). The charge entered the left wing and travelled through the aileron system before exiting the right wing (see diagram top right). Almost all the right wing, the outer section of the left wing and the

Airbrake mechanism sooted but unaffected

Aileron system bellcrank distorted

Cracked pushrod aperture
