Damage and failures

A LARGE area of bad weather with heavy falls of snow and sleet was slowly approaching Dunstable airfield from the north. K-21 GBP had been on a training flight for about an hour and was soaring in 2-3kt up, in clear air, back along the frontedge of the cloud line.

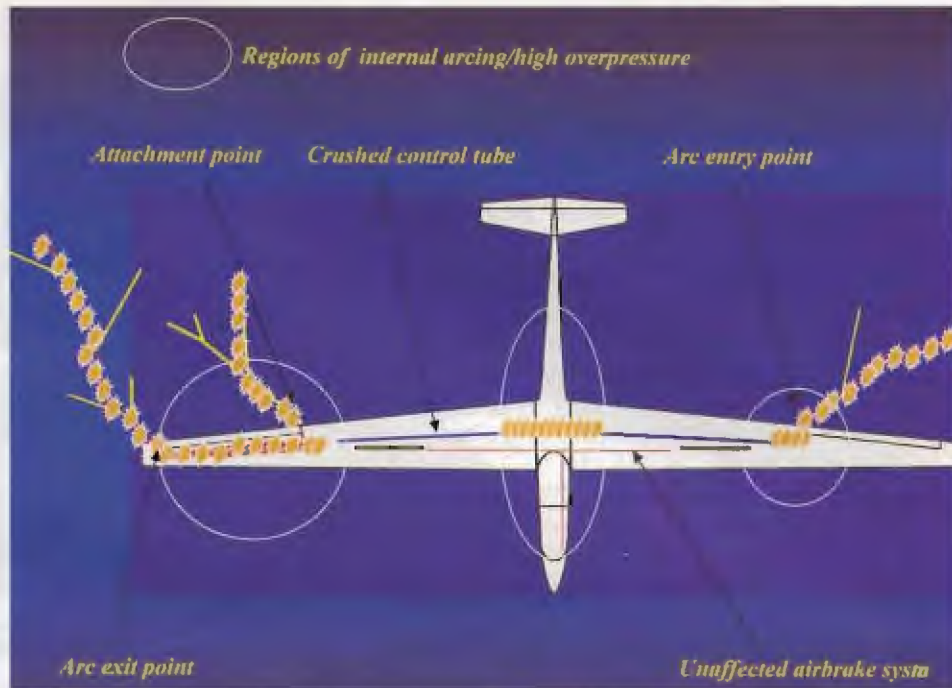
centre part of the fuselage detached in flight. The main spar connection remained and was later easily derigged. Most of the structure was recovered and examined at Farnborough. Four main areas of the glider had fragmented or been directly affected by internal overpressure in flight: the fuselage centre section; the right wing tip and the areas aft of the main spar at the inboard end of both ailerons. Most bonded joints in the wings, and the bonded seams in the centre of the fuselage, separated along the adhesive lines. Both canopies had remained securely closed, but all the perspex was shattered.

At around 17:09 hrs, it turned away to return to the airfield. Shortly afterwards, at c. 2,500ft agl – 300ft above cloudbase – and an estimated 800 yards from cloud, the glider was hit by lightning. Large sections of its airframe disintegrated.

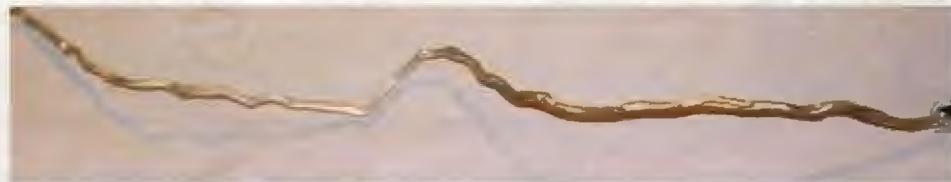
The strike damaged only the aileron system – not the adjacent airbrake system or the elevator and rudder controls. The aileron system, linked by self-aligning ball or plain bearings and by Hotellier ball and socket joints, included three aluminium alloy rods in each wing. The centre rod from the right wing was burned and eroded at each end close to its jointed connections, which were missing, and had, unusually, been “crushed” because of the intense magnetic field generated by conducting the current. The end result was an

almost solid, irregularly-shaped “bar” (pictured below right). This deformed rod, which probably reached no more than 200° C, is thought to have conducted all the current.

The lowermost of three bolts attaching this system to the steel bracket which supported the aileron bellcrank had reached a temperature in the region of 1,000° C, and melted (pictured below left). From the damage to this bolt and the pushrod, the energy level of the strike was calculated as at least eight to nine times higher than specified international lightning protection standards for aircraft.
