How the hit happened

Technical view

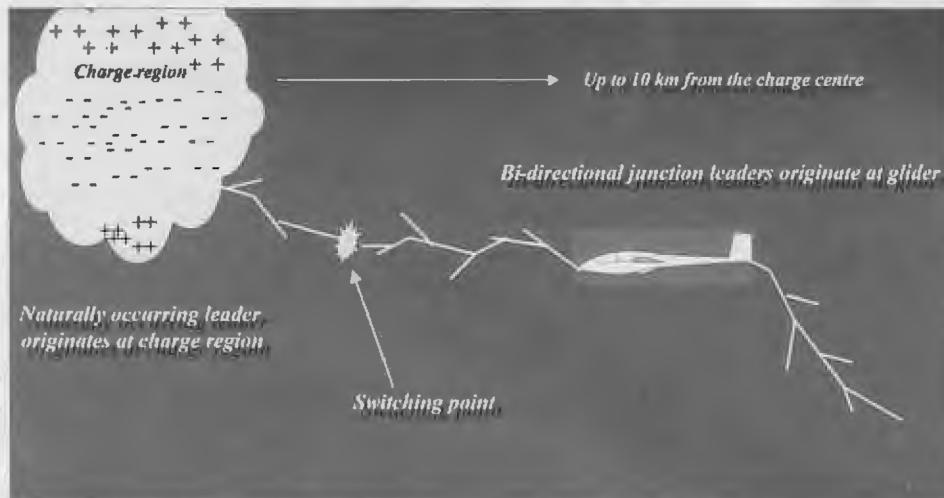
An aircraft-induced strike (see above) results when the aircraft enters an electric field associated with charged cloud regions – which can extend up to 10km from the cloud – and the field intensity around its extremities is sufficient to trigger bi-directional leaders. These link regions of opposite polarity and again conduct lightning currents through the aircraft. It is not known if GBP intercepted a strike, or if it induced one, but the effects would be similar.

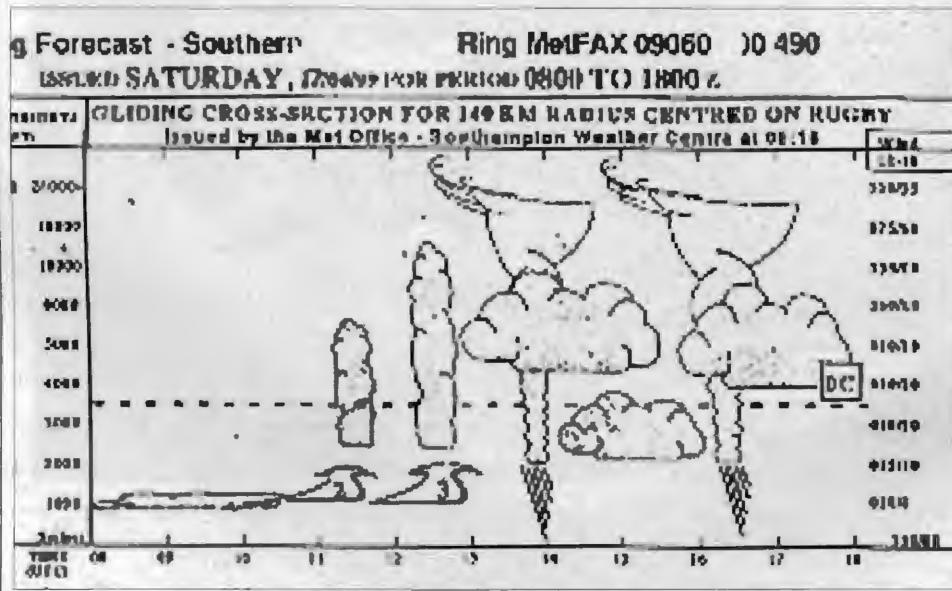
On take-off (1610 hr) the K-21 pilot reports that the cumulus was spaced two to three miles apart in an otherwise clear sky and was not greatly developed. The forecast (below) proved reasonably accurate, with warnings of severe turbulence, lightning and hail in the vicinity of cu-nims.
